COOPI

"Drought Consequences Alleviation in Borena Zone - Oromiya Regional State" Liben Wereda

Terminal report
April 2002-July 2003

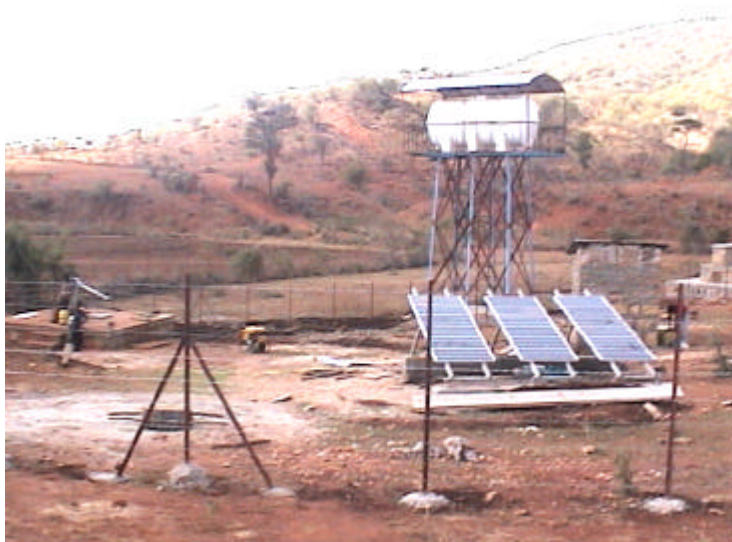
A geophysical survey was done and a good amount of water in the area was detected. At the depth of 11.50 meters the water was more than 200 litres per night. A thick plastic waterproofing rock obstructed the underground water circulation. Anyhow, during the excavation, when this was crossed, the water rapidly came up.

At the end of September 2002 the construction of the rings started and all the material for the construction was delivered to the site. The excavation stopped at a depth of 15m after that the reinforced concrete rings were installed.

Figure 6: Buradera – water works for the solar system

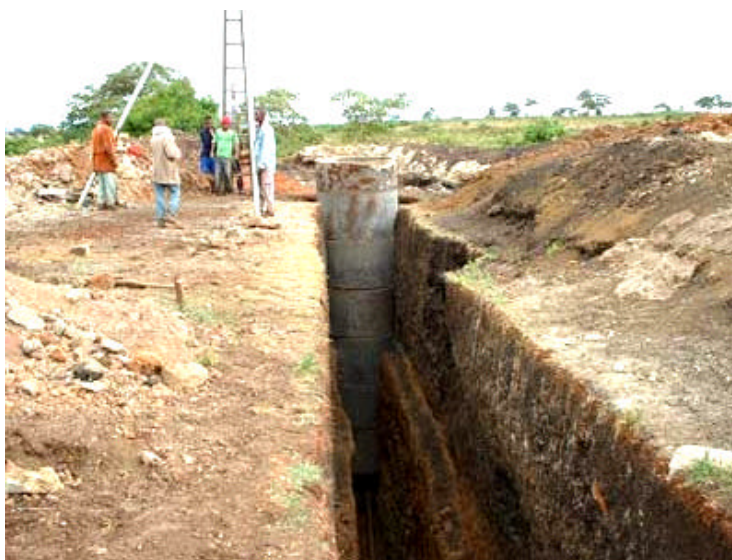
Figure 7: Wofe – water works for the solar system

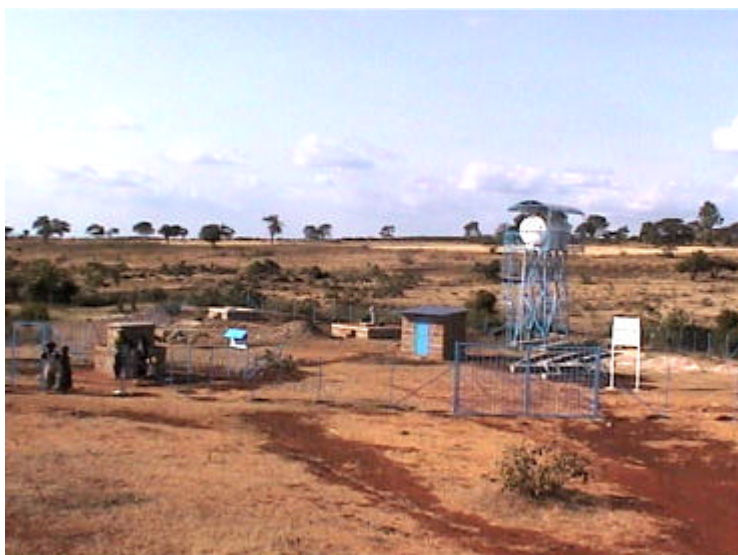
The well was excavated to a total depth of about 11m. The yield was less than the expected one and therefore it was not suitable for water exploitation with a solar pumping system. For this reason, the well construction design changed into two wells which were then connected by an underground drainage trench. A second well of 7m and a trench 14 m long and 7m depth were excavated (*Figure 7*).

The drainage trench has been packed with filter gravel up to 3m below the ground level. The remaining 4 m were backfilled with compacted selected clay to avoid infiltration of the surface water and likely contamination of the well's water.

Figure 8: Wofe Water scheme after accomplishment

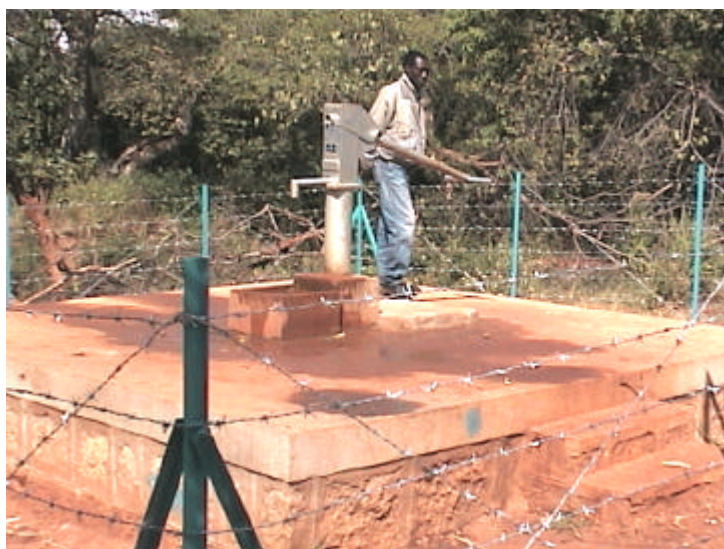
Figure 9: Tola Dhalan HDW

The particular hard condition of the area did not permit the accomplishing of the geophysical survey. The geological situation showed a not clear picture of the area but, through the help of the population, it was possible to get a general idea about the place where to dig. Unfortunately, the presence of a boulder at 6.2 meters depth forced the selection of a new place 1.5m near to the first one. At 4.5m depth a very good amount of water was found; the excavation continued up to 7.3m. A pumping test was done and a yield of 0.7 l/s was calculated.

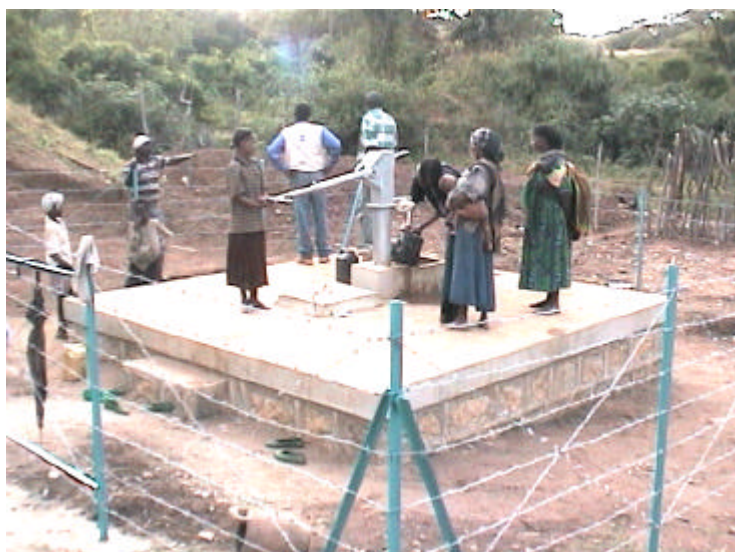
The works started in the quarter July-September 2002. During that period, the excavation was terminated after having reached the depth of 14.85m and set up of the rings was accomplished. During the excavation a suspended water table was met that did not assure the planned amount of water expected by the results of the geophysical survey. Then it was decided to keep on digging and to reach the fractured basement.

At that time the water disappeared and another decision to reach the fresh basement (representing the supporting surface of the aquifer) was taken.

Figure 10: Mucho HDW

At the end of the excavation the total amount of recharging water inside the well in the firsts 24 hours was low (7m^3), but after 48 hours the quantity increased (15m^3 approximately) and after 3 days a very high quantity (around 33m^3) was met. At that time it was decided to organise the excavation of drainage holes (80 cm of diameter and 1.5 meters long) to increase the drainage surface at the level of the static water level, in agreement with the water situation of the area. These allowed a better drainage of the aquifer and a faster recharging.

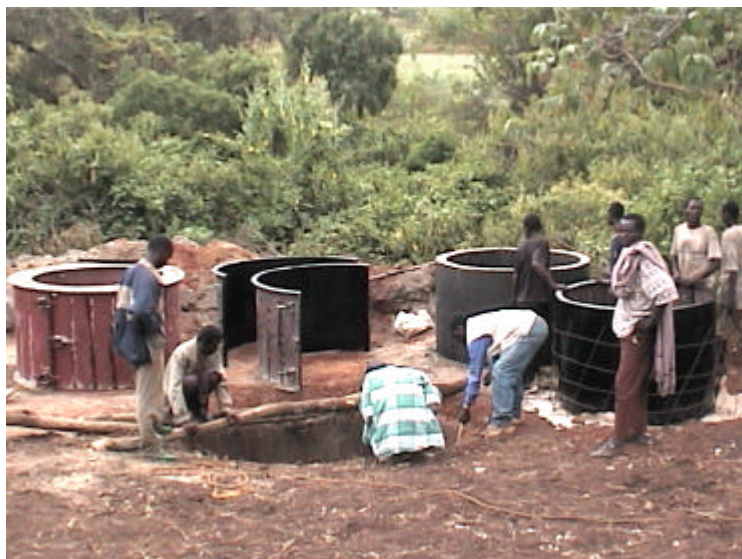
The construction started the first week of December 2002, upon receiving of a letter from the community asking help for the construction of a hand-dug well because of the lack of water. Thus, a team was organised for the excavation and the works started. The excavation was accomplished at the depth of 8.5 meters after the hard removal of the fractured biotitic gneiss rocks. The masonry works then started and the works were accomplished on January 2003. The scheme was temporarily handed over to the community that is using it.

Figure 12: Dolcha HDW during construction

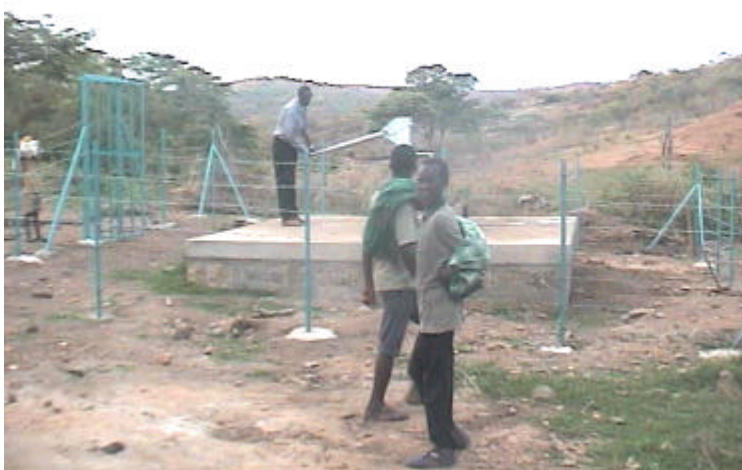
The excavation of the HDW started in coincidence of Dolcha works. The estimated depth of the well was around 4.5 meters with the aquifer estimated to be found in fractured gneissic rocks. The excavation was accomplished at 5.2m mid of December 2002 and the last days of the same month the mould for ring's construction was transported to the site. The reinforced concrete rings were constructed and installed. The overall works were accomplished on January 2003. A temporary handing over of the scheme was done to the community which is benefiting from it.

Figure 13: Bokola HDW

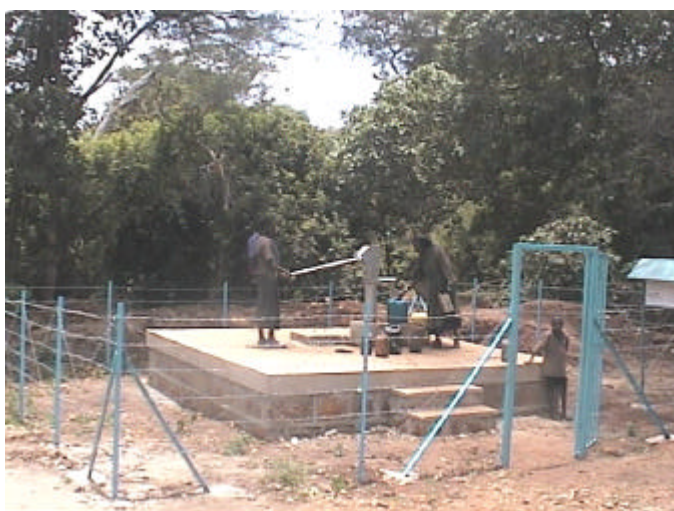
This was a new site selected during the last quarter of the project based on the hydrogeological survey and the community interest. Excavation work started and stopped after digging a depth of 5.85m. The excavation work was stopped temporarily in order to avoid the collapse before lowering the concrete rings. However, because of the sandy nature of the aquifer, the shaft was caving and, since it was not possible to go deeper, we abandoned it. Like Nurahumba site, another nearby position was selected and excavation reached around 8.1 m. The set up of the concrete rings is almost accomplished and a mason for the construction of the superstructure and the finishing works has already been assigned.

Figure 17: Mede Water Scheme

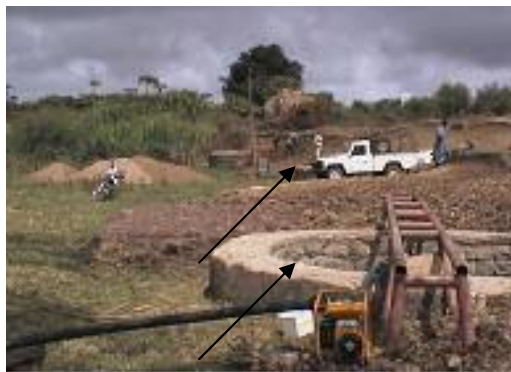
Fig-1 the topographic leveling work was carried out to prevent flooding

In the beginning the clearing was started only by focusing on well-1 and well-2, since the amount of water in overall the wells is too high to pump out all simultaneously. Thus the clearing work had been proceeding from August, 2002 to December, 2003. Beside the well clearing work topographic leveling work had been accomplished in the surrounding of the wells in order to prevent the concentration of the run off that might flood the wells. The leveling work was accomplished by cutting and filling, and it covers an area 75m X50m.

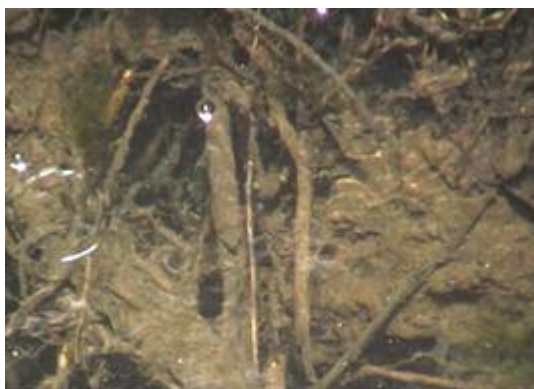
Fig-2 the wells were full of indigenous materials.

It was not possible to clear the other three wells simultaneously with the first two wells because of the necessity of big capacity pumps that able to drop down the water level of the area significantly and because of the swampy nature of the terrain.

To eradicate the swamp around the wells two drainage ditches of length 45m and 60m were constructed along the main stream line that pass though the well field. As result the terrain becomes dry so we were able to work on the rest of three wells. Moreover we were able to clear the rest of the wells by using high capacity pumps.

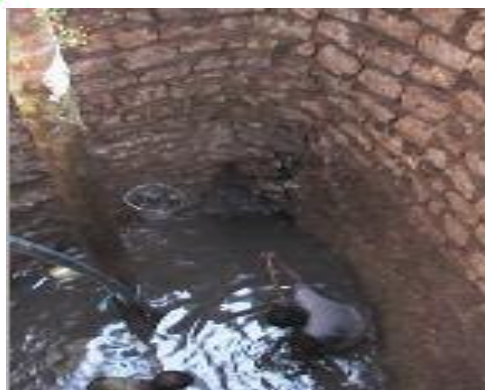
Fig-3 peoples clearing the well, while pumping was on progress

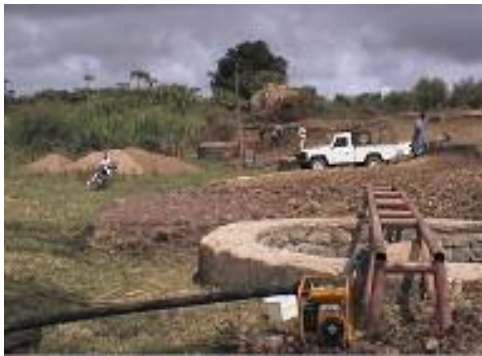
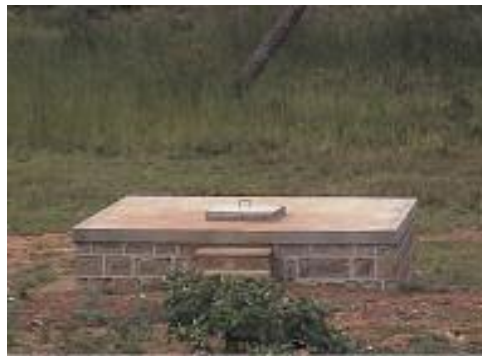
Fig-5 I- the previous not covered circular wells head II- the new rectangular wells head with top slab cover

The well head construction work includes disrupting of the previous un proper (un covered) circular well heads and construction new rectangular masonry wall around the each well to sufficient height as well as covering the top by reinforced concrete slab with man hole.

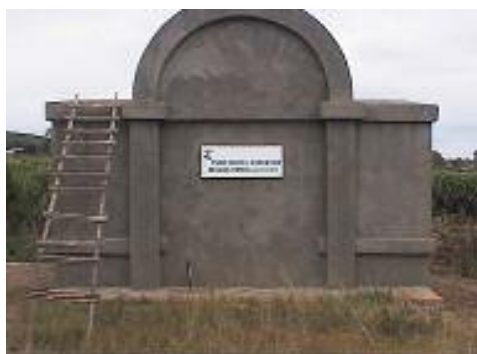
Fig-6 The outlook of the reservoir from the front side

As compare to the other structures, the reservoir is not very much affected. The part the reservoir that needs rehabilitation is:

The side wall has cracks which can be maintained by chiseling and plastering. Therefore, the work had been done by chiseling and plastering of the wall in the internal part. The outer wall of the reservoir is also maintained by coarse plastering.

The wash out that made of GI pipe was broken at the inner bottom part of the reservoir because of corrosion. There was an attempt to maintain it by replacing with another pipe by chiseling and pulling out from the broken point. However, chisel in to deep body of the reservoir though to cause serious damage on the foundation. Rather we preferred chisel up to 30 cm deep in to the wall and fixed it by mortar after replacing the old pipe by the new one. In order to control the leakage fully, flat iron with paint of anti-rust fixed from the inner part the reservoir by removable bolt and nut. The manhole covered by iron sheet of size 0.81m*0.81m.

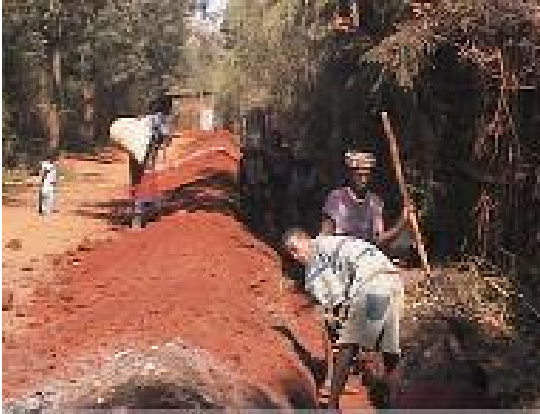
Fig-8 workers at the trench excavation work

The main (it named main trench to differ it from the trench for power line) trench excavation work had been carried out manually, and the dimension of the trench excavation decided based on the suggestion from the Water Department expertise. The width of the trench was 0.6m trough out the route, and the depth was 0.9 m below the ground level. However, the depth of the trench reduced to 0.60m because of massive rock layer encountered along the route from the near by of the dam to the north end of Water Service Office compound. Beside, in the compound of the Power Generator Plant of ELPA we encountered outcropped massive granite rock layer and the layer totally not possible to crush, thus the pipe line left bare on the surface for some 25m.

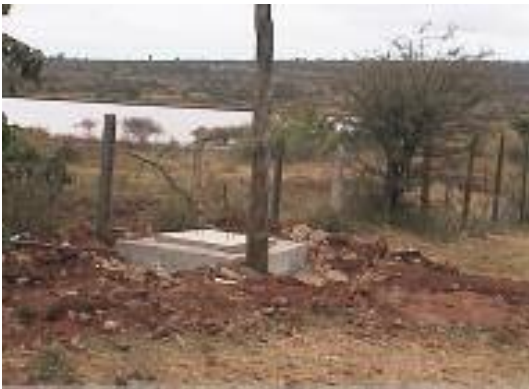
Fig-9 manholes with concrete slab cover constructed in seven places where they are necessary

Necessary fittings such as Elbows, Joints, Get valves and Check valves are fixed with the line according to there necessity. Elbows are used in every point to create 900 turning and Joints are used to make the line easy to dismantle during maintenance. Get valves are fixed in seven places along the route to the treatment plant from the reservoir, to control the back flow of water in case when needed to maintain the line and masonry manholes with size of 0.8m by 0.8m constructed on the places where Get valves are fixed.

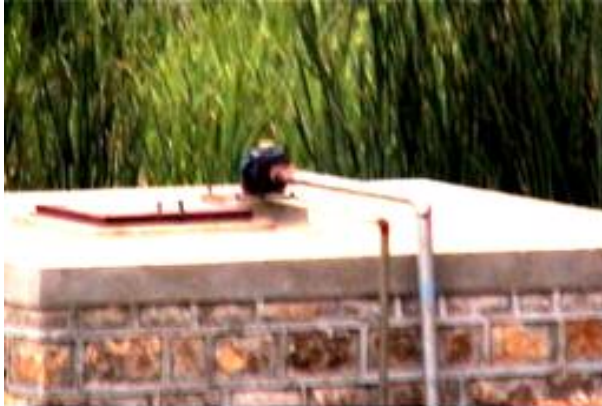
Fig-10 the submersible pump installed on well number three with water counter.

During the test, after the final installation of the pump, the pump can deliver 4.72 liters of water per second with existing head difference between the water level inside the well and the reservoir inlet.

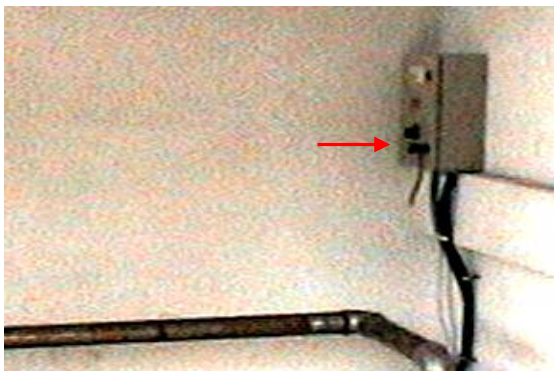
Fig-11 the electric control switch board for the submersible pump installed inside the main pump house.

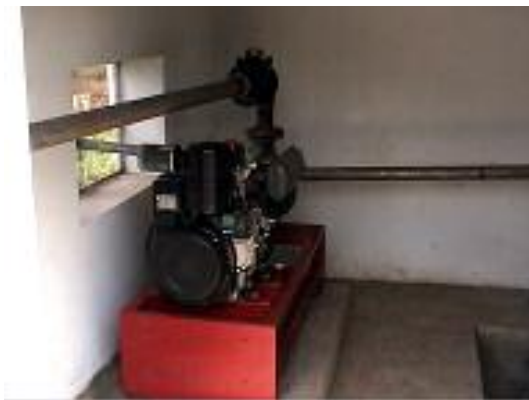
Fig-12 the surface pump installed inside the pump house.

The pump mantled on the reinforced concrete slab of size 0.60m by 1.45m and by 20cm high, which constructed inside the main pumping house. It is connected with the reservoir through existing outlet by 2 1/2 inch galvanized iron pipe. The characteristics of the pump are listed below:

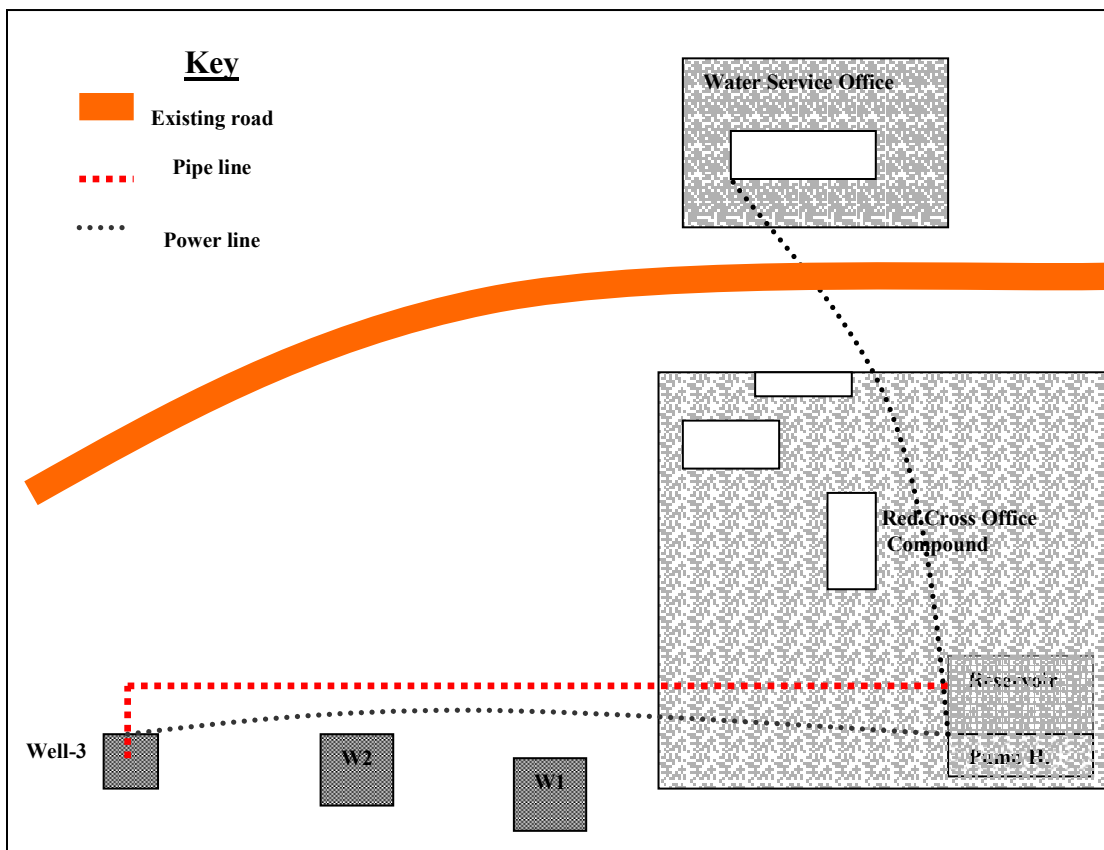
Map-4 The route of Power line and the pie line from the well to the reservioure

- The line supporting poles are hallowed by termites.
- The cables are broken and partly lost.
- Because of the corrosion, the conductivity of the cables is significantly reduced.
- Some Electrical fittings such as Insulators are missing

Based on the suggestion from the respective expertise the line set under ground. PET electric cable of size 35mm/4mm used. The line prolong from the Water Service Office to the pump house, where the electric control switch board installed, through the compound of RED Cross Negele office. Then after the line go to the main well (well-three) where the Submersible pump installed. The over all length of the line along the route is 306m, and the line buried in the trench, which excavated priory, with depth of 1m below ground level. After all, the line connected with the existing power line switch of Water Service Office.
